CITY OF LODI COUNCIL COMMUNICATION

AGENDA TITLE: Receive Report Regarding Status of Mokelumne River Bank in the General Vicinity of Pigs Lake within Lodi Lake Nature Area

Re: Lodi Lake Nature Area Erosion Along Mokelumne River

Lodi Lake Park
Mokelumne River/Pig Lake Erosion Sites

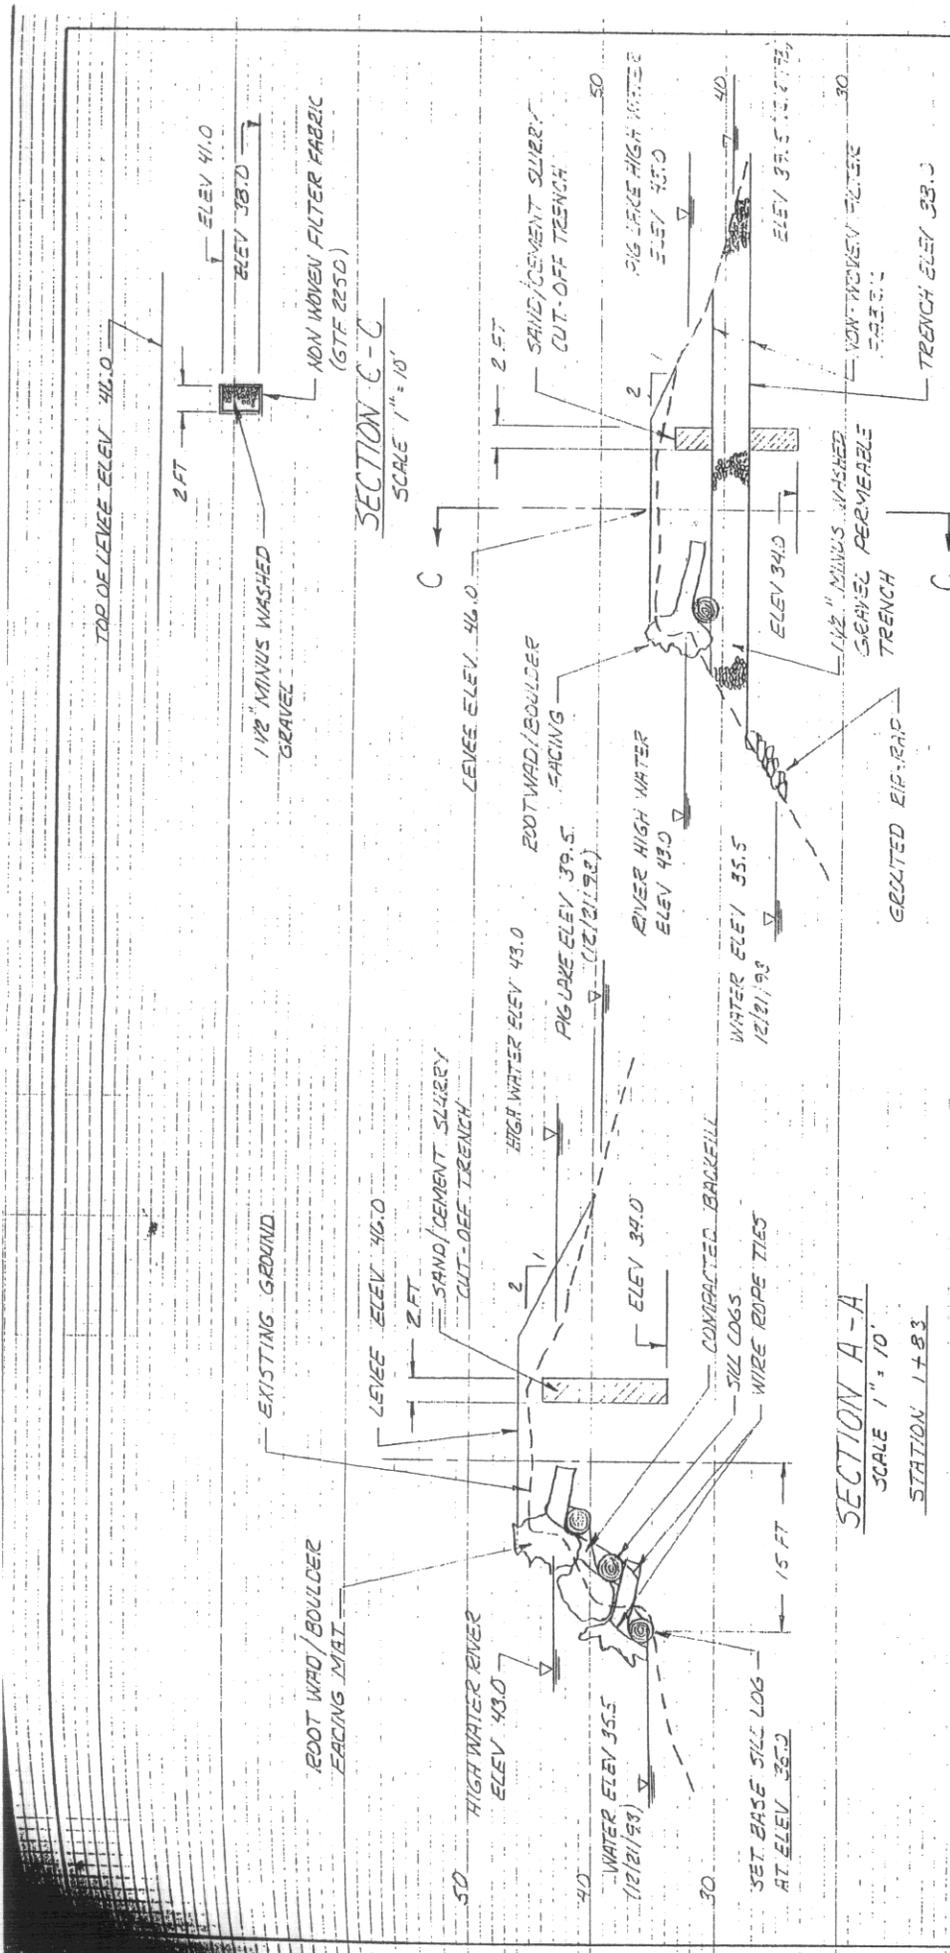
PIG LAKE - LEVEE REPAIR PLAN SHEET			
CITY OF LODI - PARKS AND RECREATION	DESIGNED BY	DATE	SCALE
	D. LAMPE	12/93	1" = 10'
Lampe Engineering		614 NORD HWY CHICO CA 95926

SECTION B-B
 SCALE 1" = 10'
 STATION 1+55

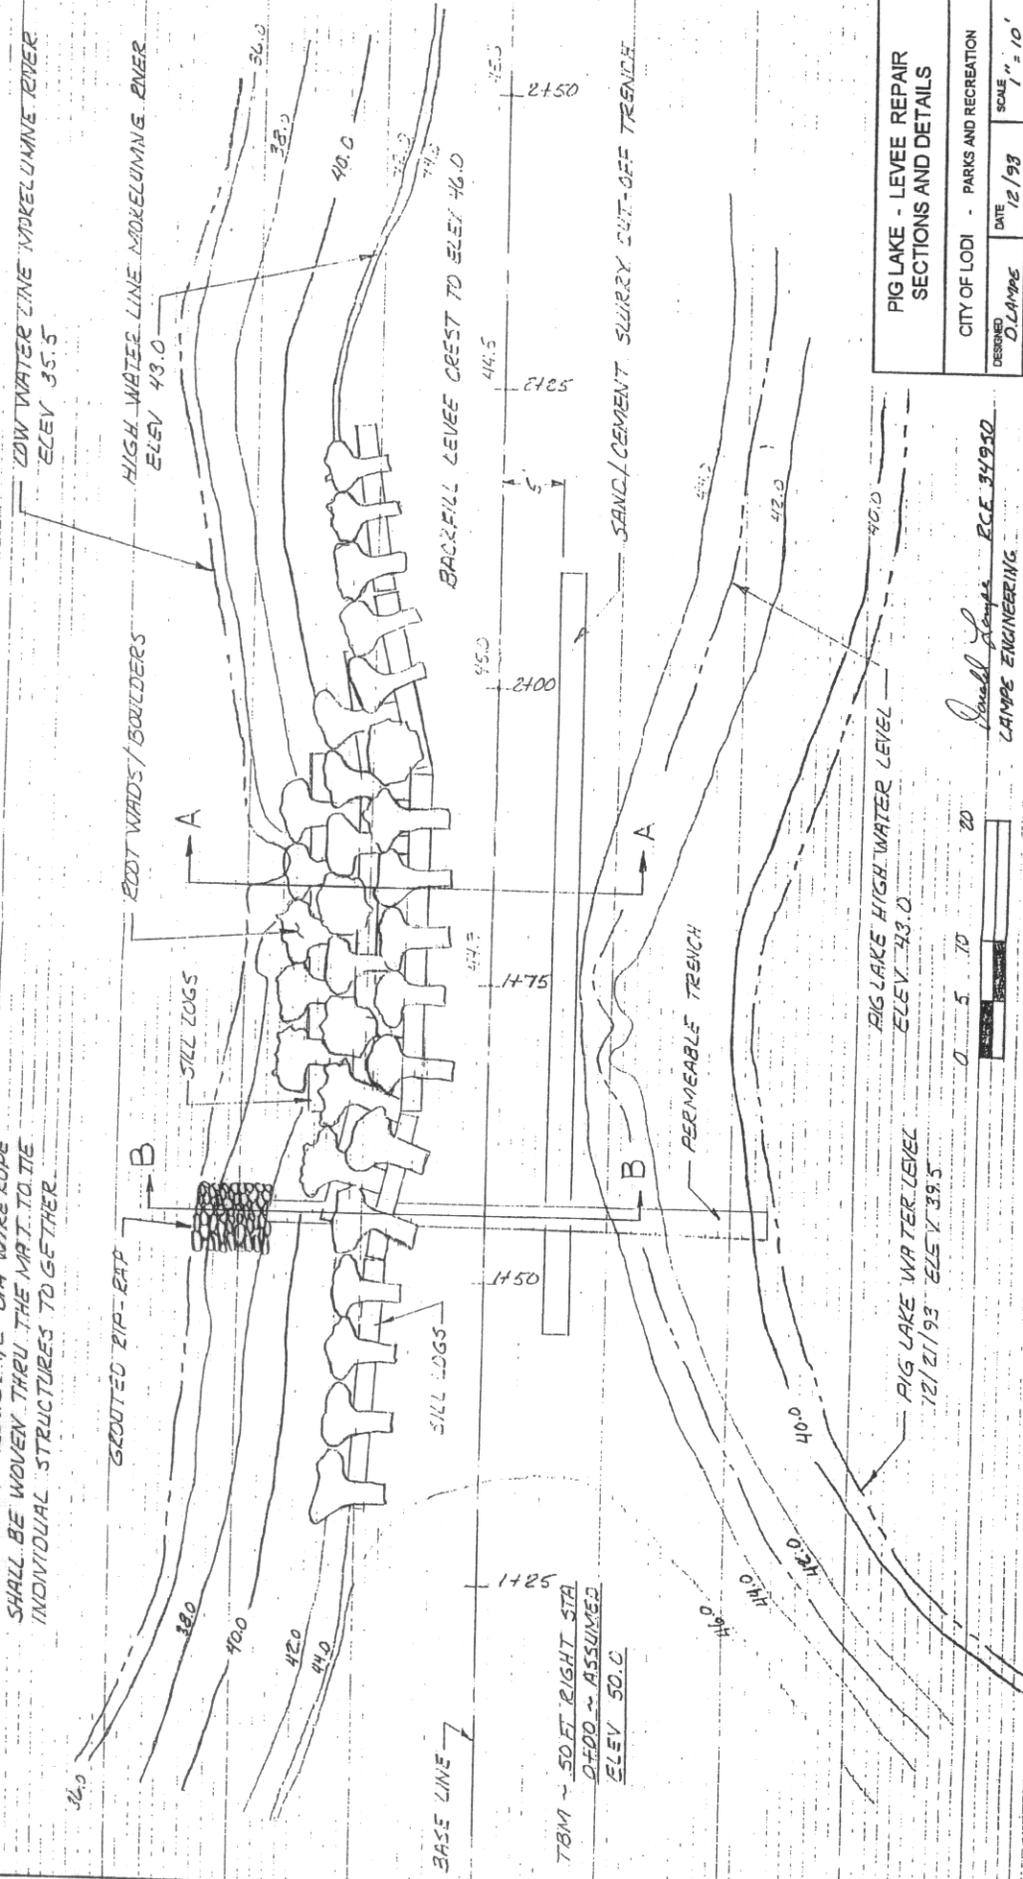
PIG LAKE - LEVEE REPAIR SECTIONS AND DETAILS

1. LARGE Boulders MAY REPLACE ROOT WADS PLACED ALTERNATELY UP TO 50% OF TOTAL AREA ~ Boulders SHALL BE 3'-5' DIA

2. ROOT WADS/BOULDERS SHALL BE PLACED TIGHTLY, OVERLAPPING SILL LOGS AND SUBSEQUENT ROWS. 1/2" DIA WIRE ROPE SHALL BE WOVEN THRU THE MAT. TO TIE INDIVIDUAL STRUCTURES TOGETHER.

3. VOIDS BETWEEN STRUCTURES SHALL BE BACKFILLED AND PLANTED WITH NATIVE SPECIES. (SEE PLANTING SCHEDULE)

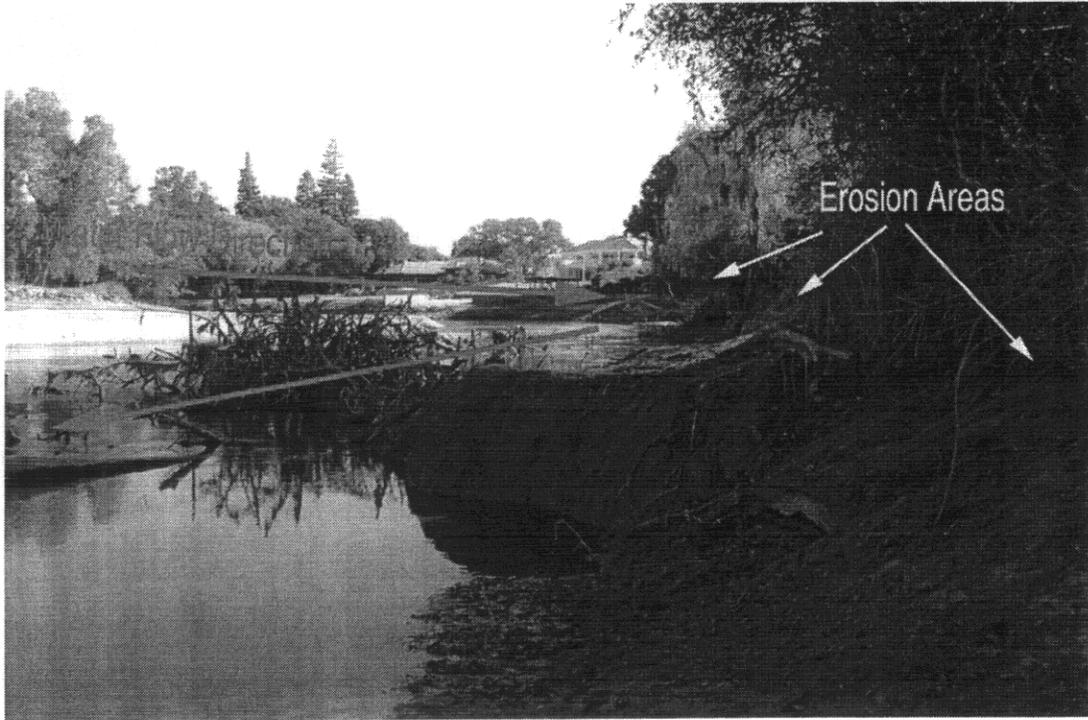
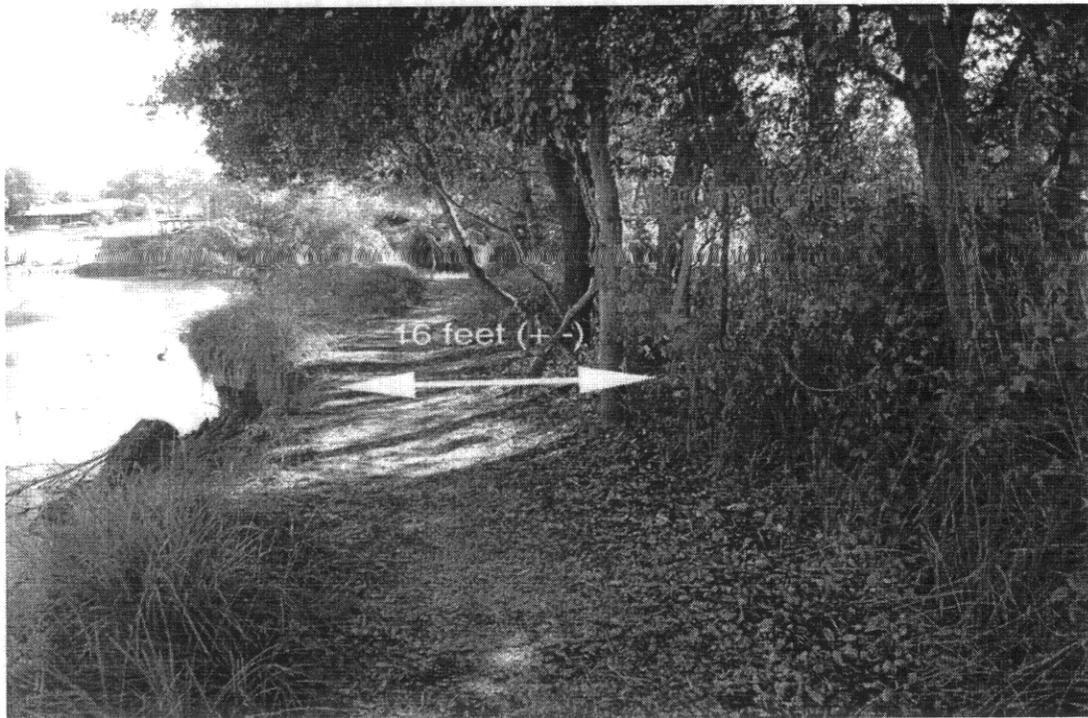
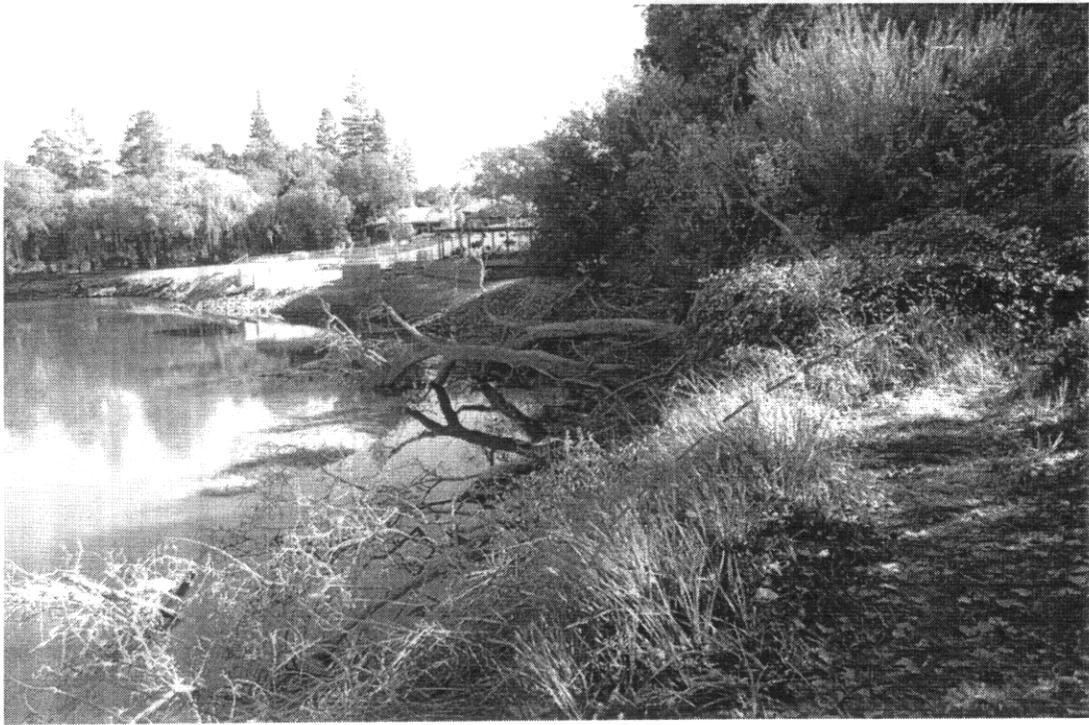
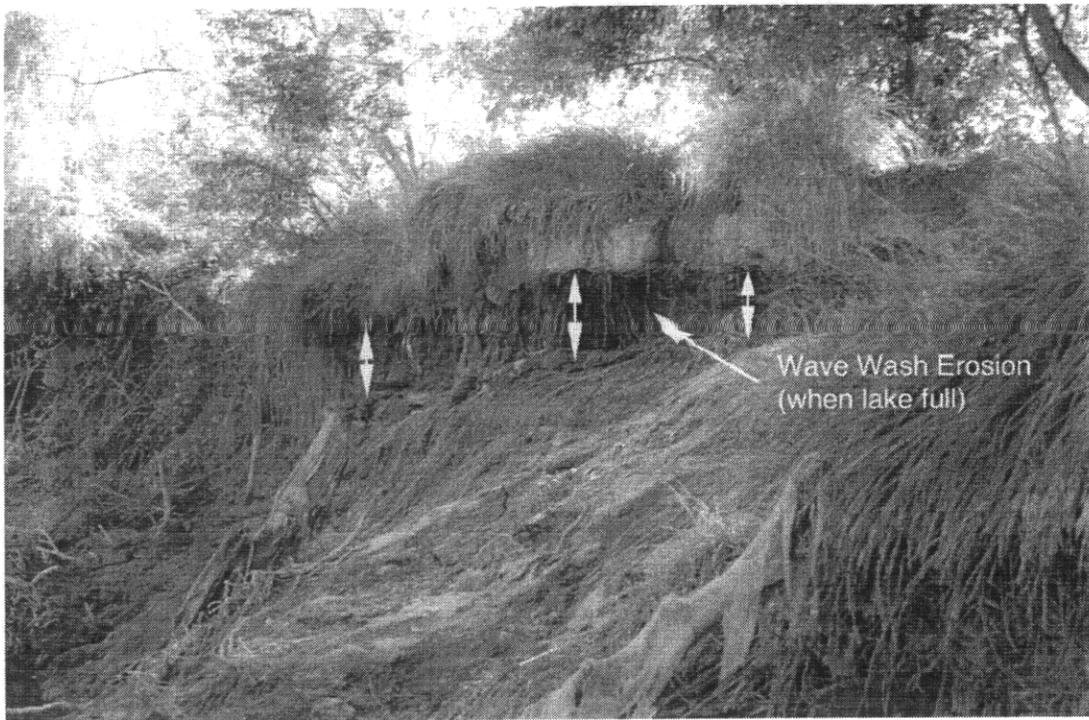
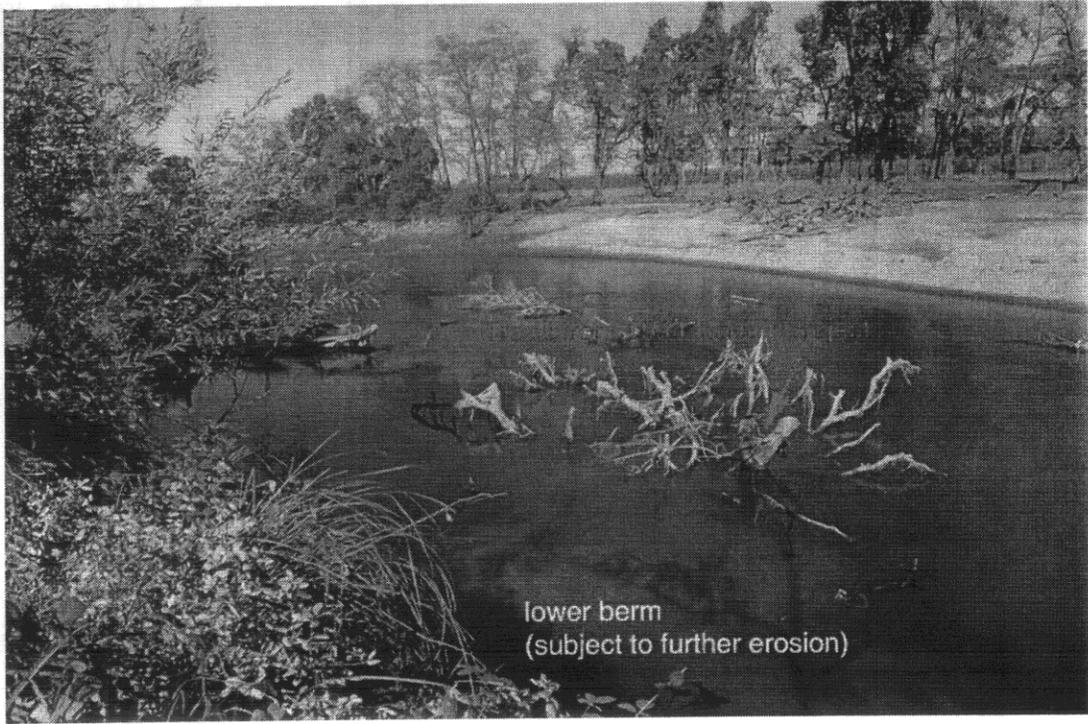
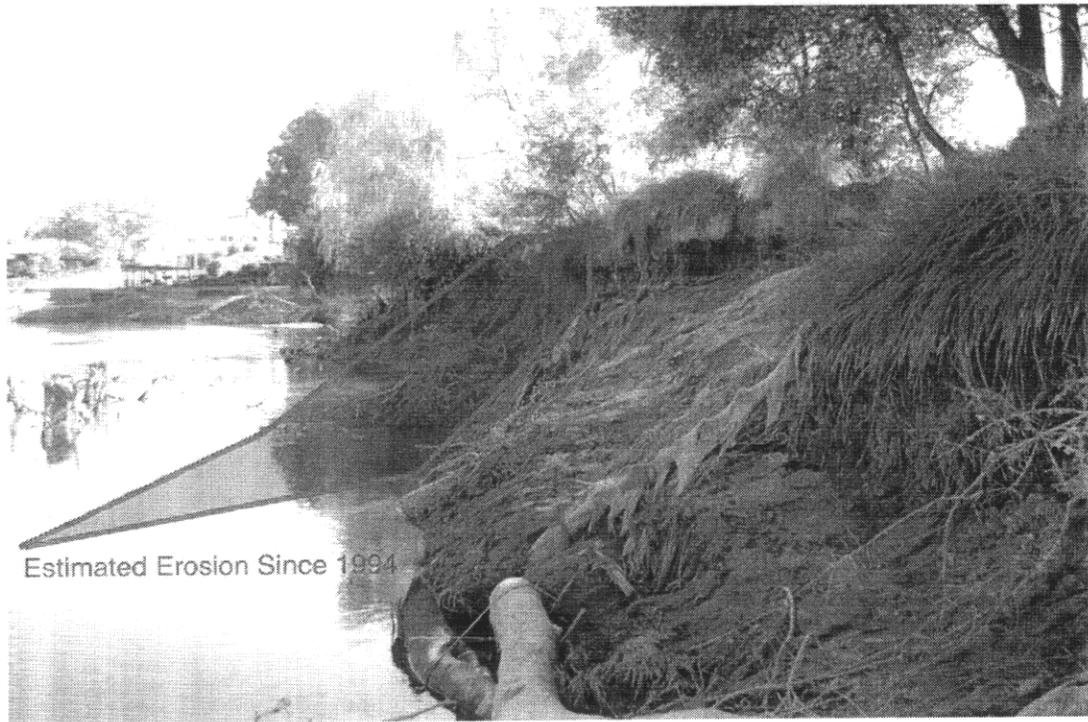
As shown in the attached photos, erosion has occurred on the right bank of the Mokelumne River upstream of the Lodi Lake dam in the vicinity of Pig Lake. The erosion site is approximately 300 feet in length and is located just downstream of a 180 degree bend in the River that causes the lower portions of the river bank at the site to be exposed to the hydraulic cutting action of the river. Erosion is occurring higher up on the river bank slope at the waterline due to wave run up from the wakes of watercraft. This wave erosion has caused undercutting of the bank up to 3 feet in some places. The soil at the site is predominately a cohesionless, fine silty sand that erodes quite readily.

First, there is hydraulic erosion occurring below the waterline that has undermined and washed out a previous repair project that was completed in 1994 (see attached drawings dated 12/93). The erosion area is located on the outside of a bend in the river, where velocities tend to be the greatest. The previous repairs appear to have consisted of stacking a grid of tree roots and logs along the eroded bank and cabling them to existing live trees along the shoreline. Remnants of the trees and logs used for the 1994 repair project remain scattered throughout the river bottom and bank of the site as shown in the attached photos. The remnant trees and logs may be aggravating the hydraulic cutting action of the river as they could be creating eddies and turbulence that are contributing to the erosion of the river bank.

Second, there appears to be wave wash erosion occurring at the summer water line when Lodi Lake is full. The waves are generated by both boats and wind. This erosion is clearly defined and localized at the top of the waterside slope. The wave wash was observed during the August inspection when watercraft passed the site.

Following a review of the 1994 repair project plans and the inspection observations, it is estimated that approximately 4 to 10 feet of the embankment crest has eroded away. In some places less than 15 feet of riverbank separate the river from Pig Lake.

Based upon our understanding of the issues and the City's goals, it is our recommendation that the scope of work for the preliminary report include the following.
